RE: Principal One Community Development District – Annual Report

Attachment A

Location Map and Photos

Field Visit by John Eason, PE
On December 22, 2014

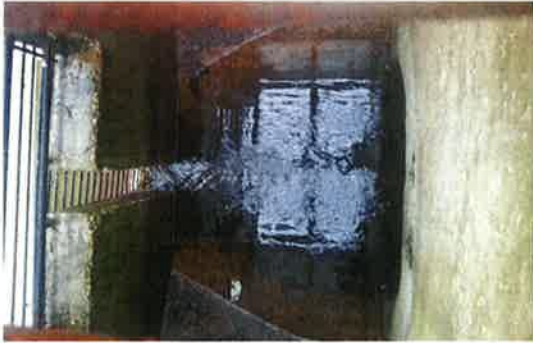
01-Inside of Control Structure for Lake 2

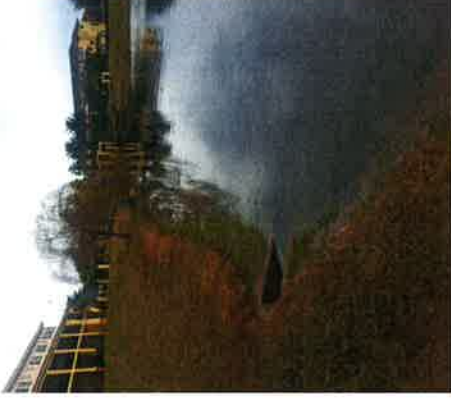
03-Looking west along south bank of Lake 2

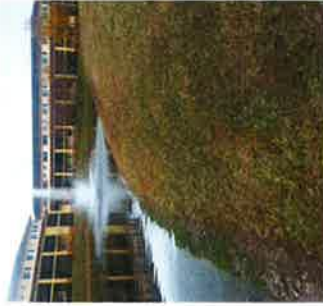
04-Looking east along south bank of Lake 2

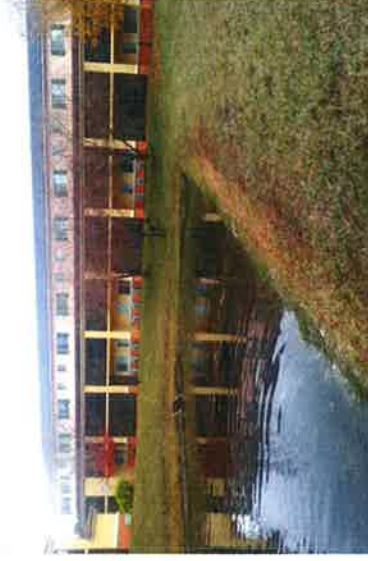
05-Looking east along south bank of Lake 2

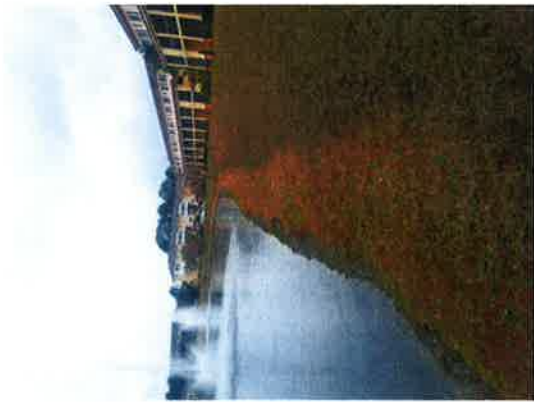
06-Looking west along north bank of Lake 2

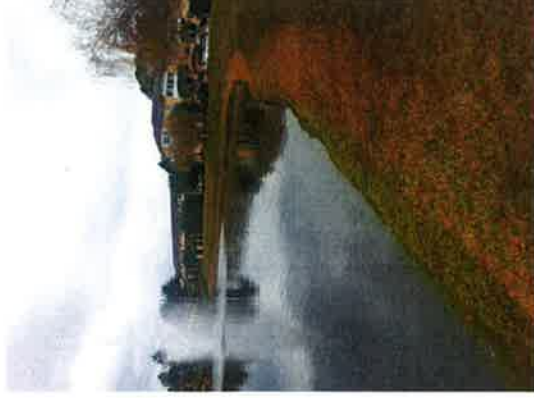
07-Looking west along north bank of Lake 2

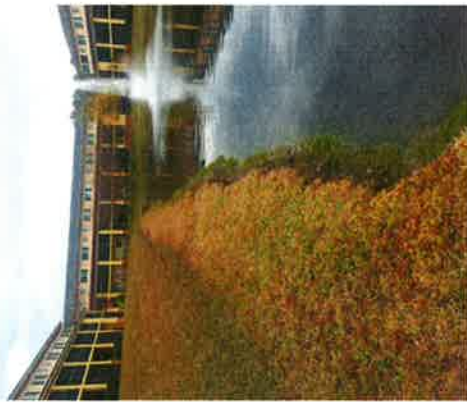
08- Looking East along north bank of Lake 2

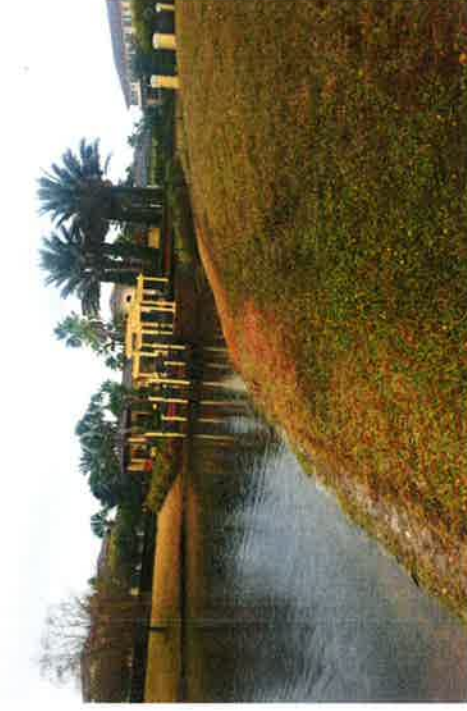
09-East end of Lake 2

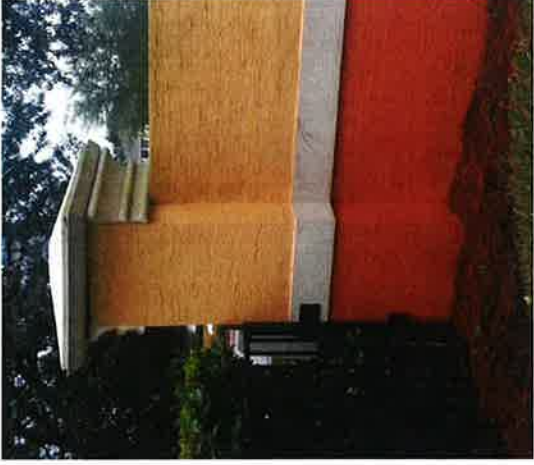
A visual inspection of the decorative walls within Parcel No. 146036-2950 was completed. During the visit, only minor cracks at the seams of the stucco wall were evident. On the east corner of the landscape wall, the crown molding on the top of the eastern most wall pillar appears to be noticeably leaning. In addition, multiple locations along the styrofoam trim along the wall showed peeling and bubbling of the paint. Since these elements are for aesthetic purposes, it is at the discretion of the CDD on whether to repair.

13- Missing Molding

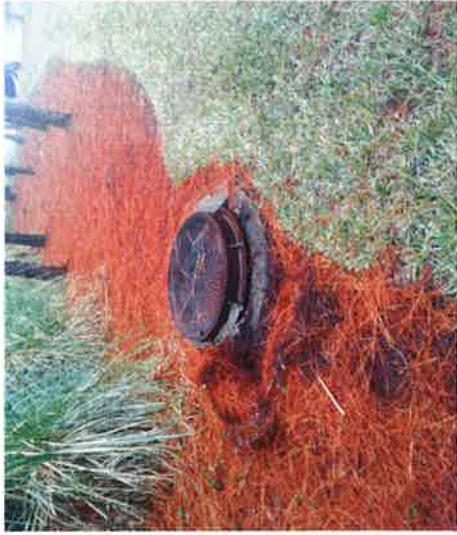
11- Cracked concrete collar around storm manhole

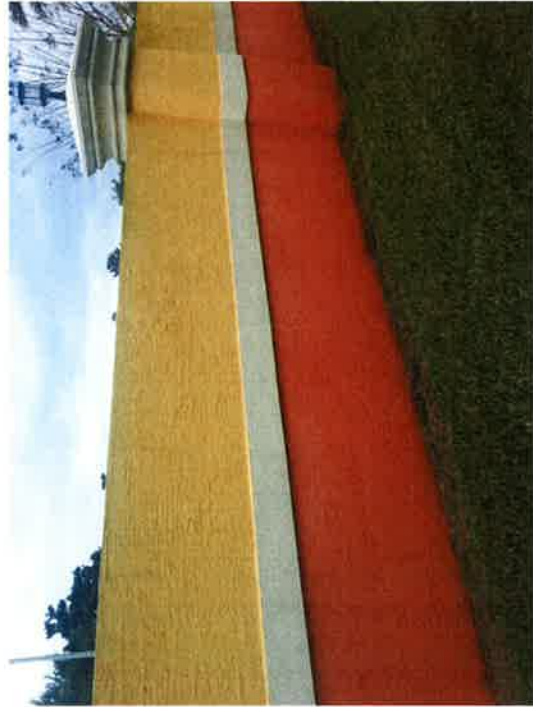
14-Vertical cracks along wall

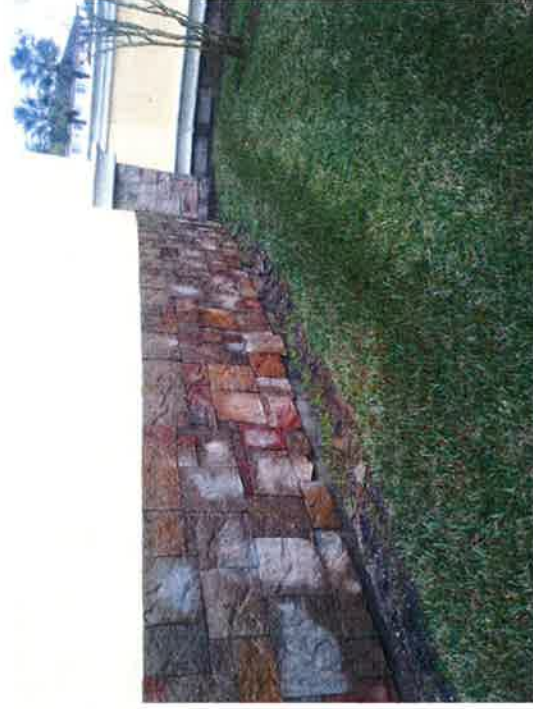
16-Stone facing chipped off or missing from bottom of wall

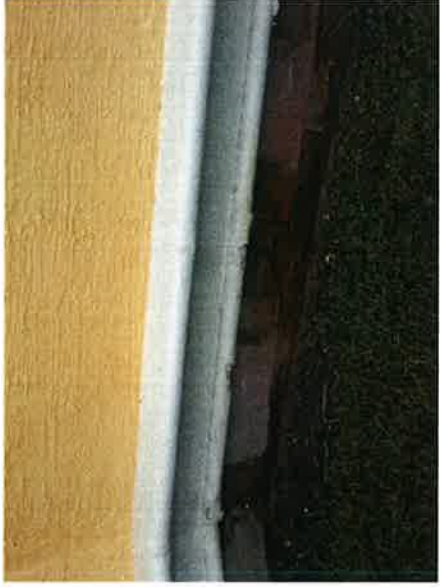
19-Peeling paint and bubbling along stucco

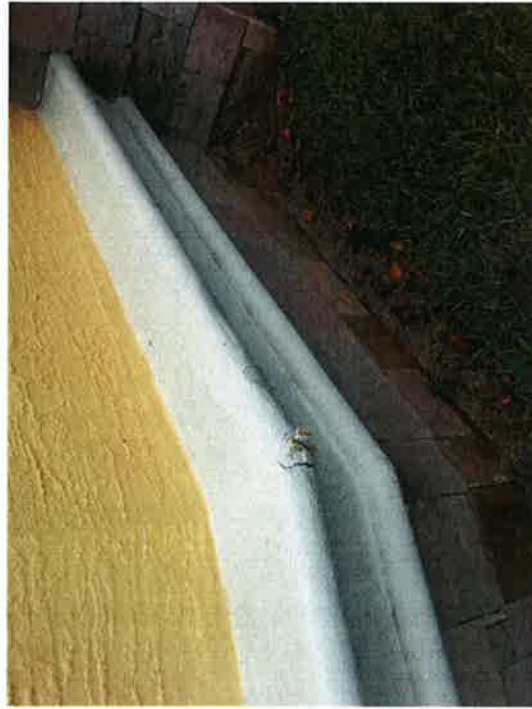
20-Peeling paint and bubbling along stucco

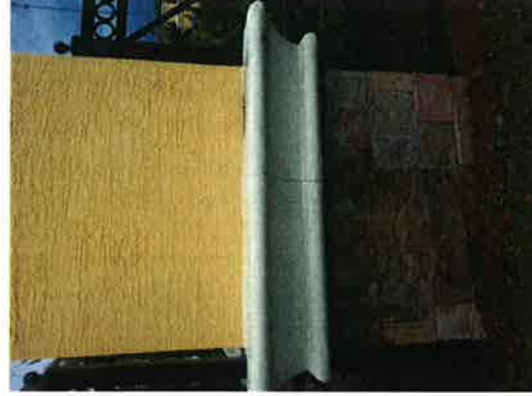
22-Crack in stucco

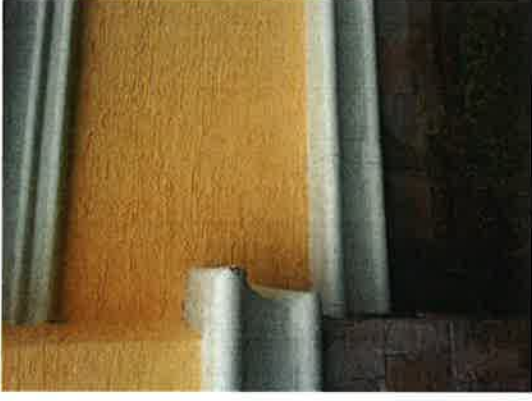
24- Peeling paint and vertical Crack

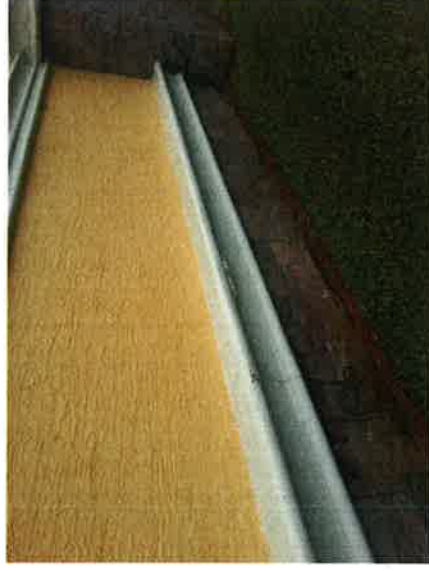
26-Vertical Crack along Stucco

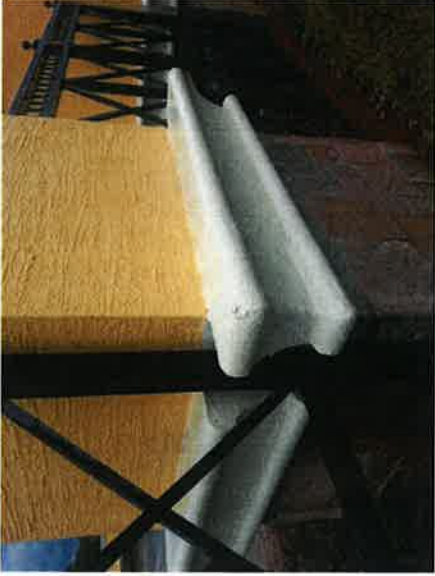
23-Peeling paint and bubbling at corner

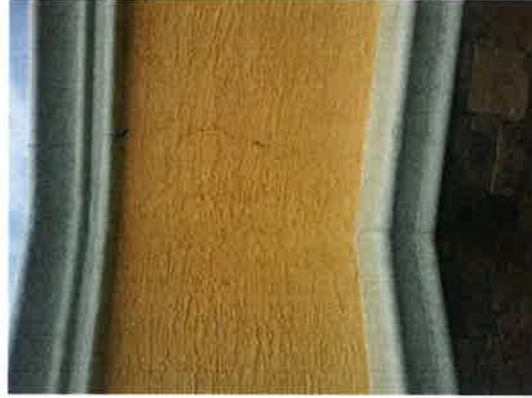
25-Vertical Crack along Stucco

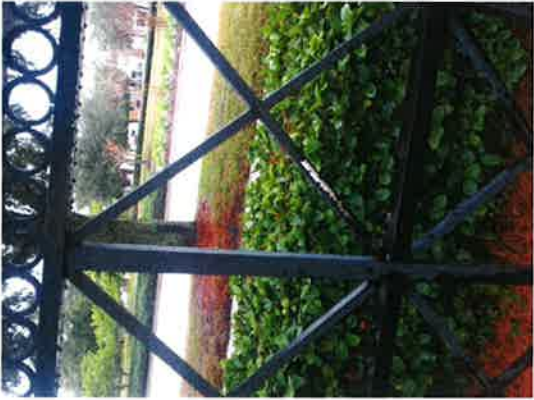
28-Peeling paint on decorative fencing

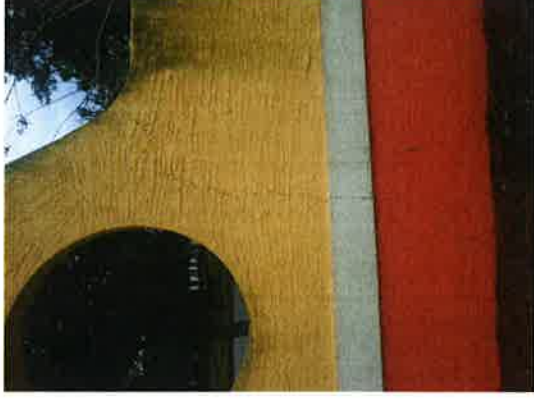
29-Crack down stucco

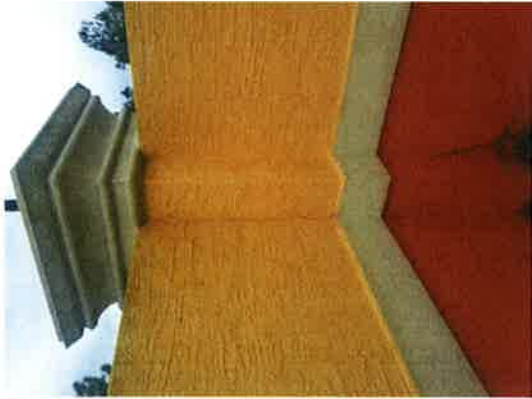
30-Vertical crack at corner of Wall

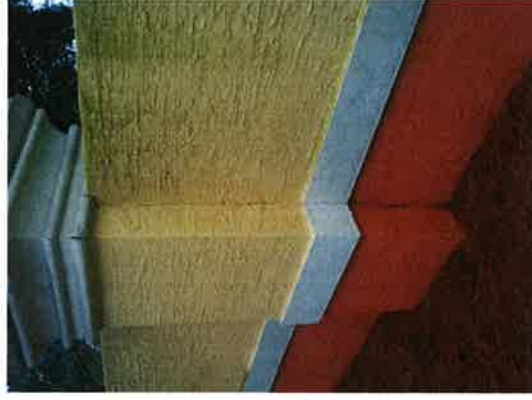
32-Vertical Crack down corner of wall

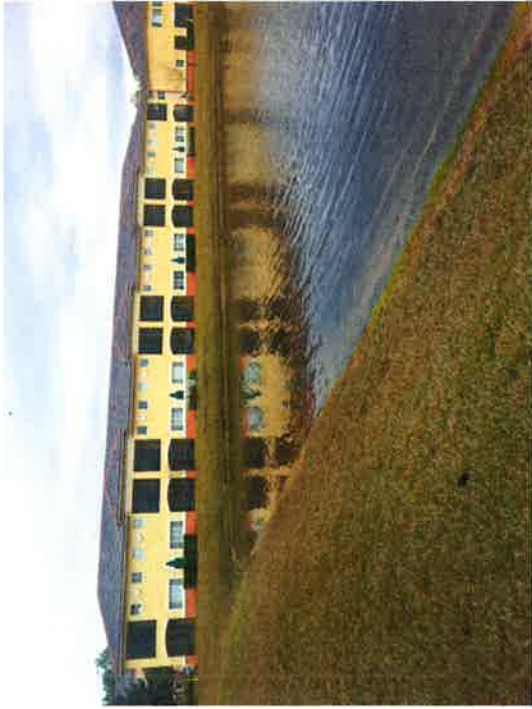
33-Northwest corner of Lake 1

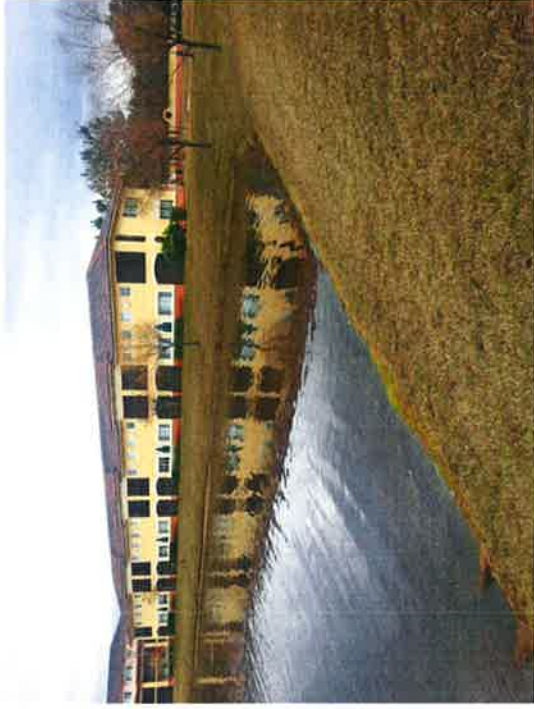
34-Southwest corner of Lake 1

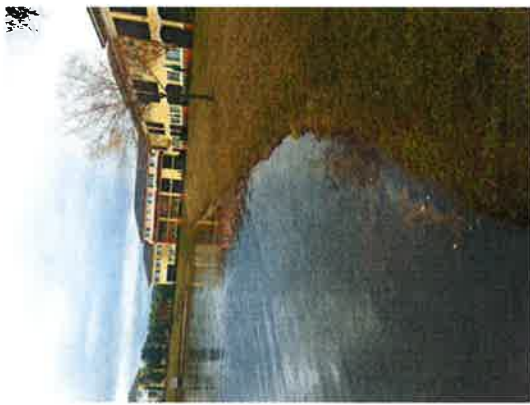
35-Looking east along south bank of Lake 1

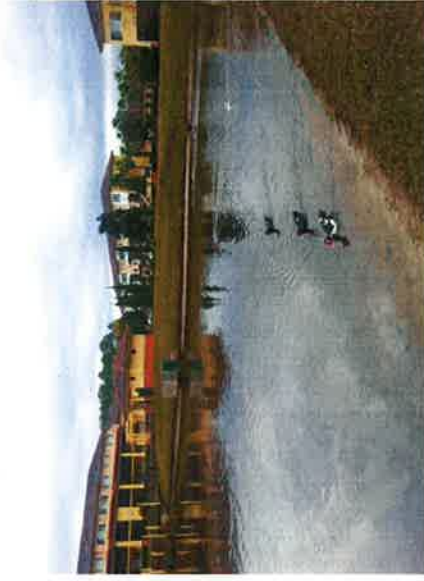
36- Looking at control structure for Lake 1

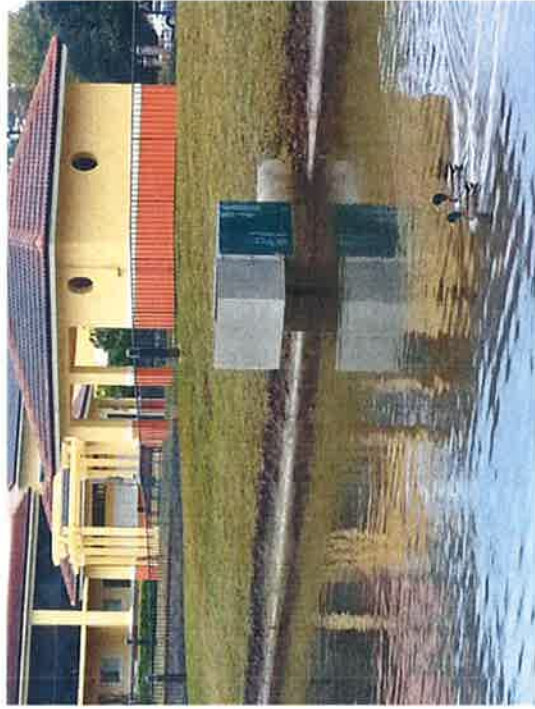
37-Control Structure for Lake 1

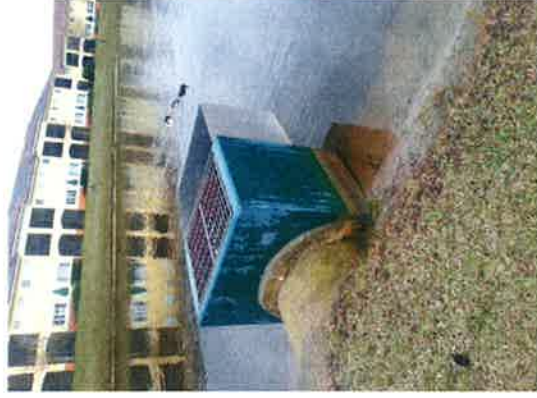
39-Control Structure for Lake 1

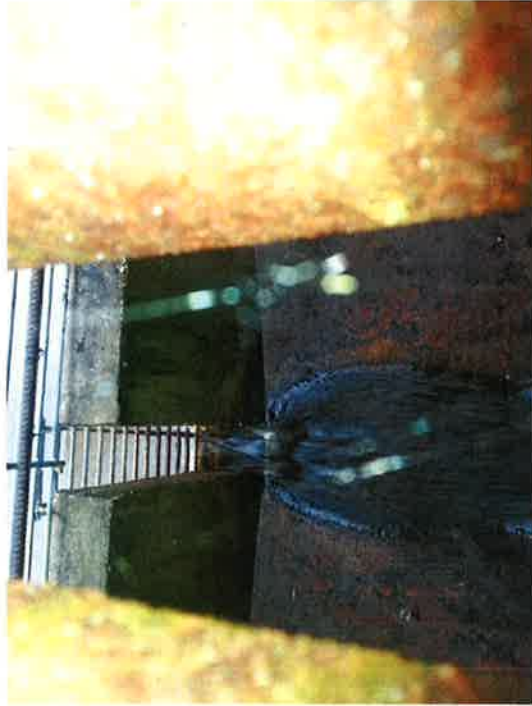
40-Inside of control Structure for Lake 1

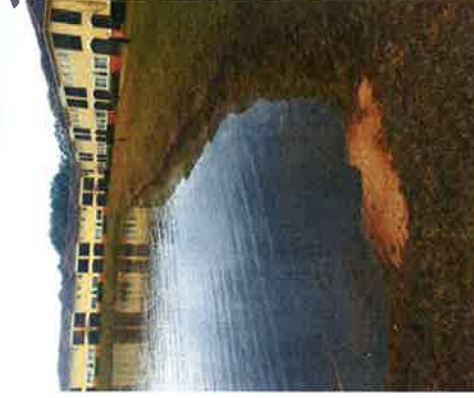
41-Looking west along north bank of Lake 1

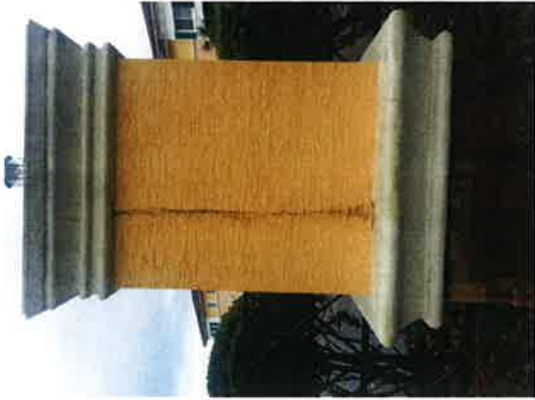
42-Vertical Crack in stucco

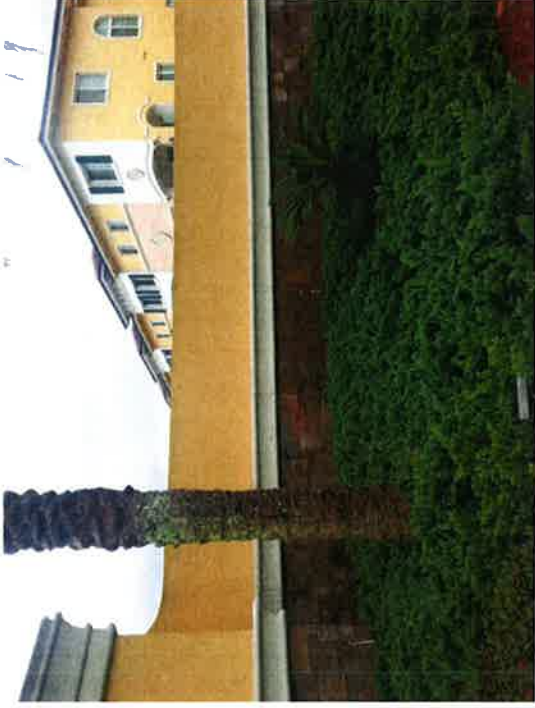
43-Multiple Cracks along stucco of wall

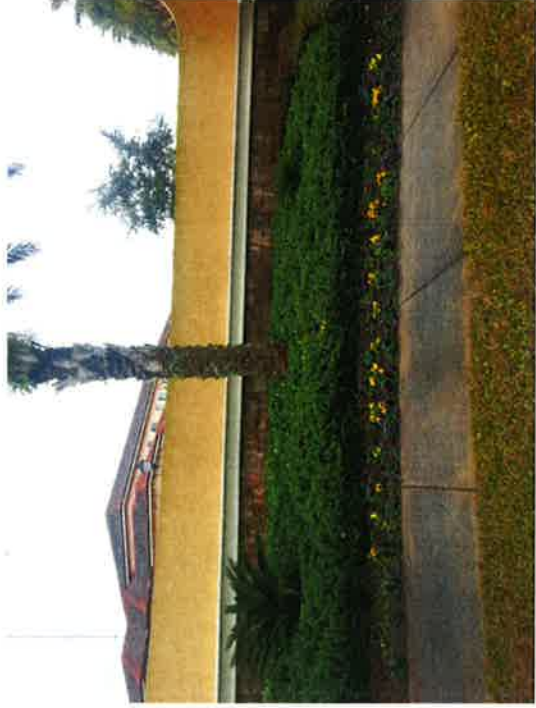
44-Multiple Cracks along stucco of wall

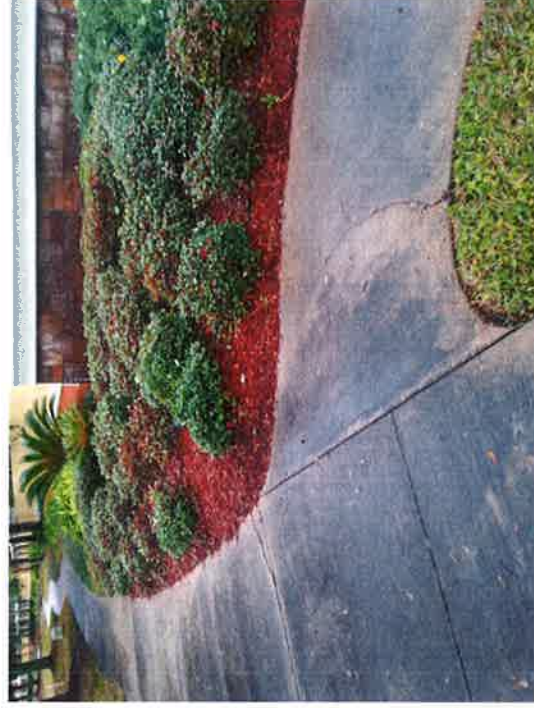
45-Cracking in sidewalk

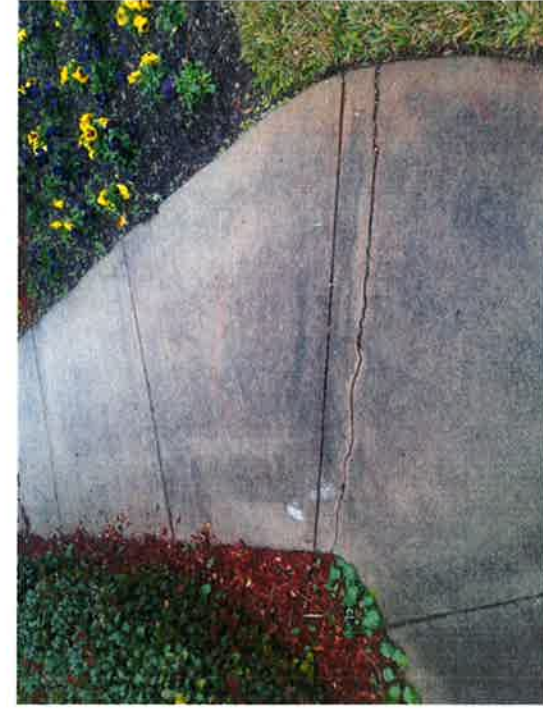
46-Crack in sidewalk

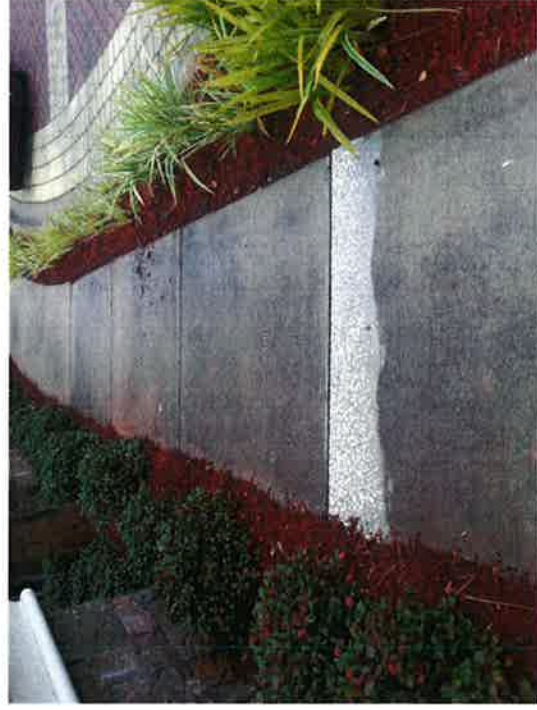
47-Grinding of sidewalk to eliminate deflection

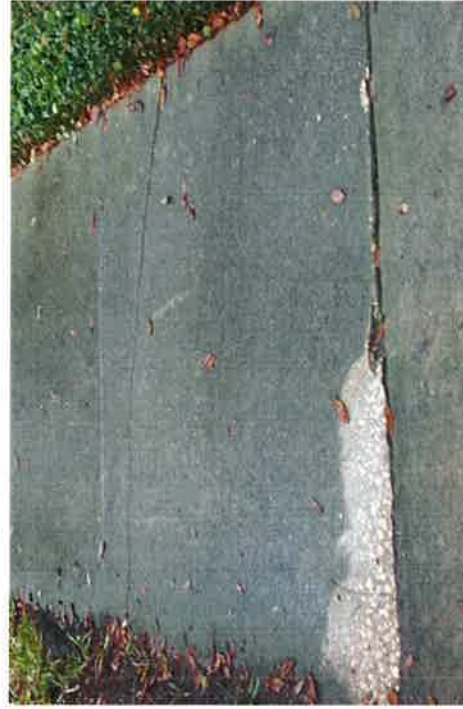
48-Cracking of Sidewalk; grinding down of sidewalk to eliminate deflection

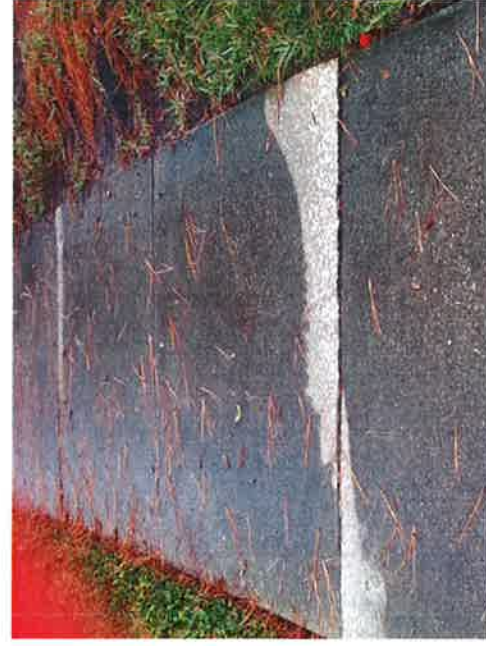
49-Cracking of Sidewalk, grinding down of Sidewalk to eliminate deflection

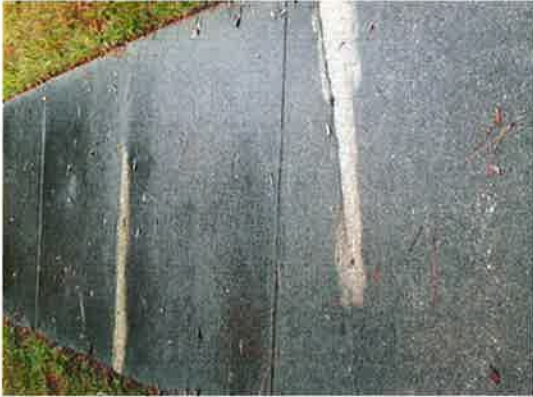
50-Cracking of Sidewalk; grinding down of sidewalk to eliminate deflection

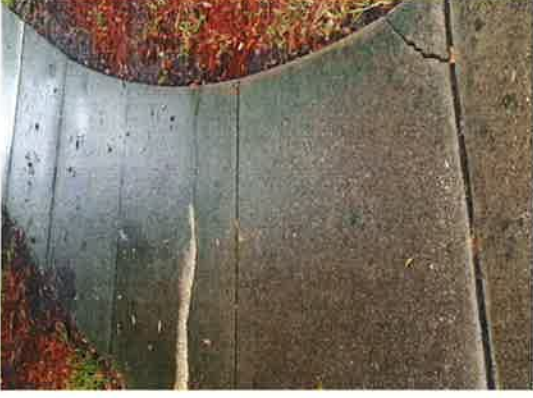
51-Cracking of Sidewalk

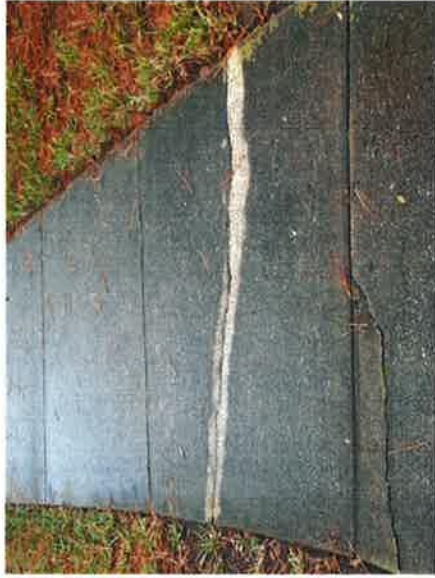
52-Cracking of Sidewalk; grinding down of sidewalk to eliminate deflection

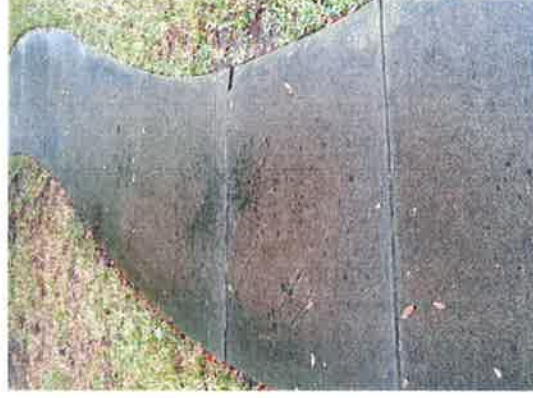
53-Cracking of Sidewalk

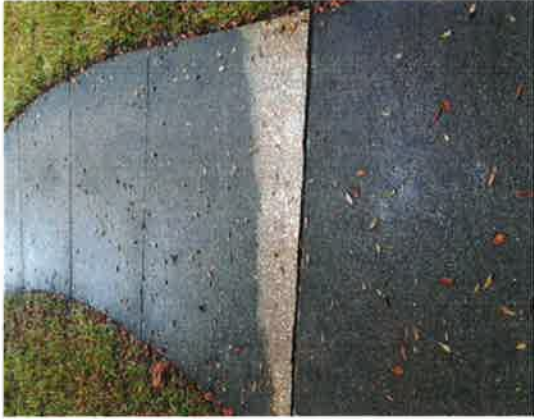
54-Cracking of Sidewalk; grinding down of sidewalk to eliminate deflection

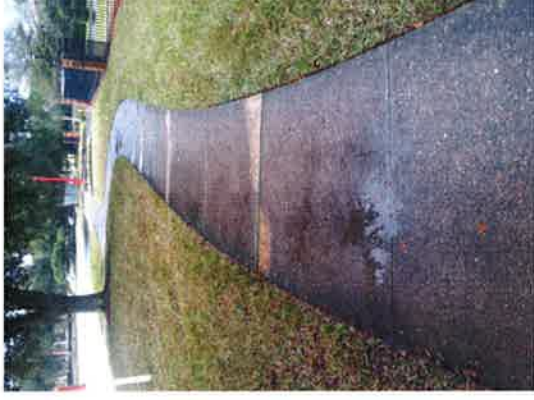
55--Cracking of Sidewalk; grinding down of sidewalk to eliminate deflection

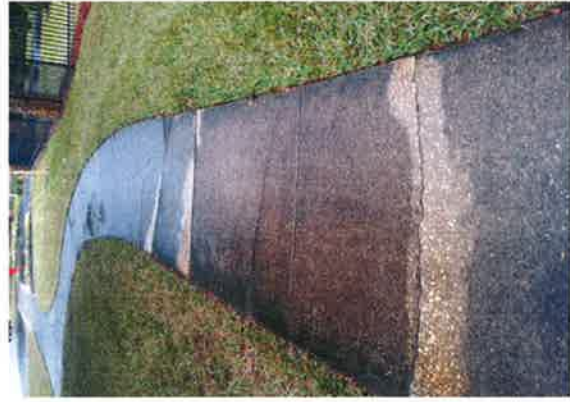
56-Cracking of Sidewalk, grinding down of Sidewalk to eliminate deflection

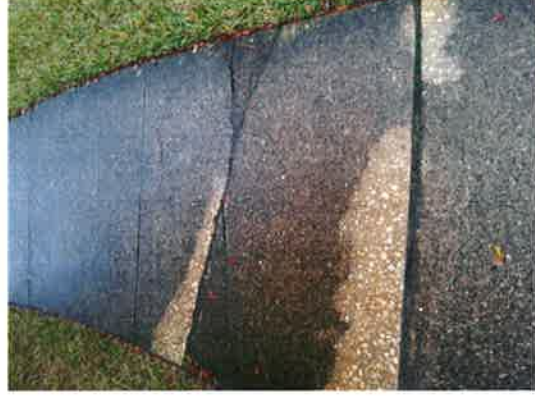
57-Cracking of Sidewalk; grinding down of sidewalk to eliminate deflection
